台南縣苓和國小(CHY016)

TM2

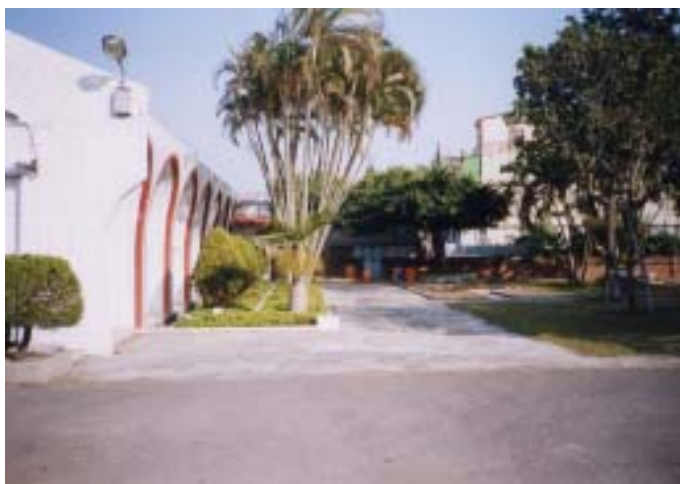
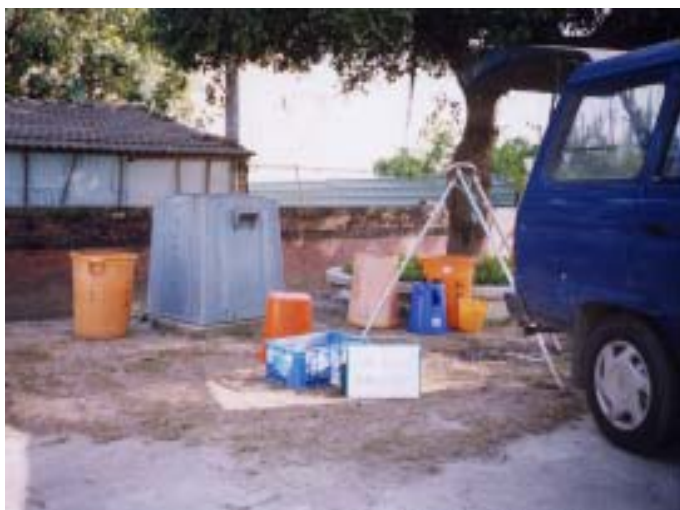
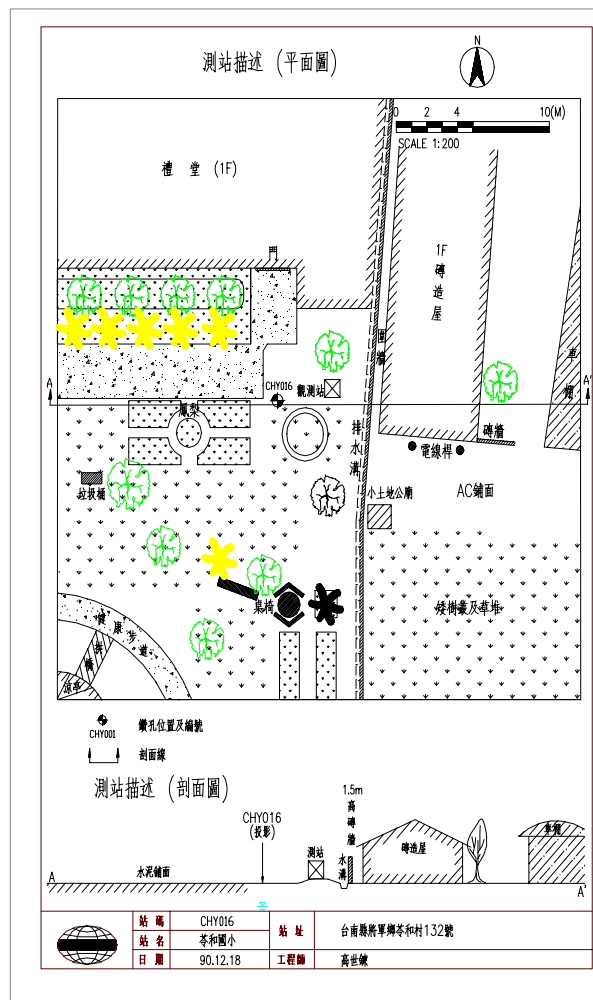
- 1.測站在禮堂南側.
- 2.鑽孔距測站約兩米.
- 3.測站附近無破壞,裂縫現象.
