台北縣山佳國小(TAP044)
 座標 289802 2763266
 西元2007年8月24日

A-2-38

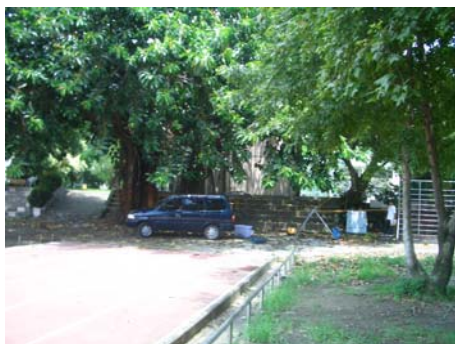
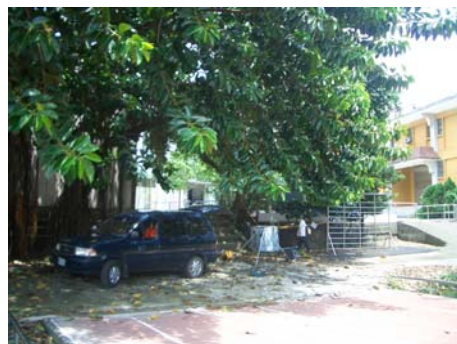
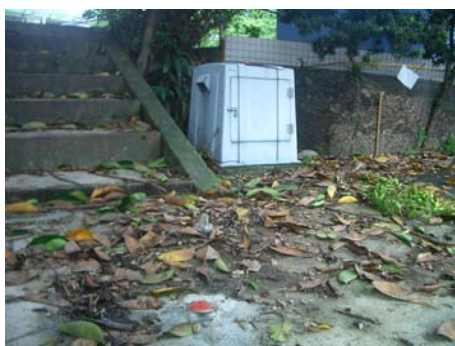
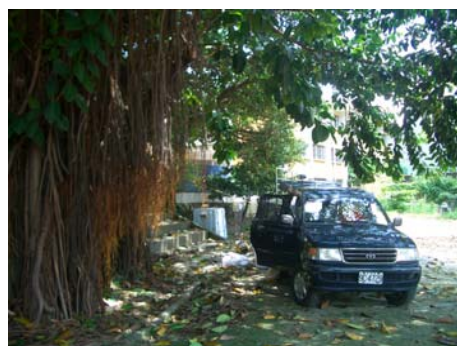
- 1 測站與鑽孔均位於操場東北方向。
- 2 測站距鑽孔約1.5m。
- 3 測站之北側與東北側為溜冰場，高差約2m。
